Diffuser Modifications Correct Recurring Cavitation Problem

Multistage, Double-Case Boiler Feed Pump

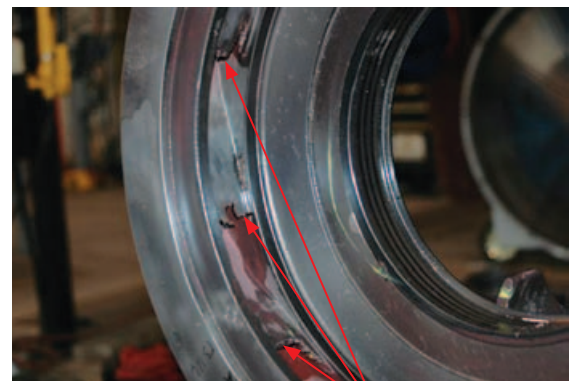
Inspections in 2005 and 2010 showed the cavitation and excessive wear continued despite the 1997 modifications.

Diffuser Damage

After reviewing the collected data and performing a root cause analysis, Flowserve engineers determined the cavitation and wear were caused by flow instabilities compounded by operating the pump below BEP. When operated at flows below BEP, high specific speed pumps such as these can develop mismatched angles of incidence between the flow and the diffuser blade tips. In this case, the poor angles of incidence were creating local areas of pressure drop and recirculation within diffuser passageways, resulting in cavitation and wear.

- Increase the “B-gap” between the impeller blade tips and the vanes of the first and second stage diffusers from 3.4% to 6.5%.
- Remove the bias wedges that were added in 1997.
- Operate the pumps at or near BEP, whether by changing the operating parameters or by implementing rerates.

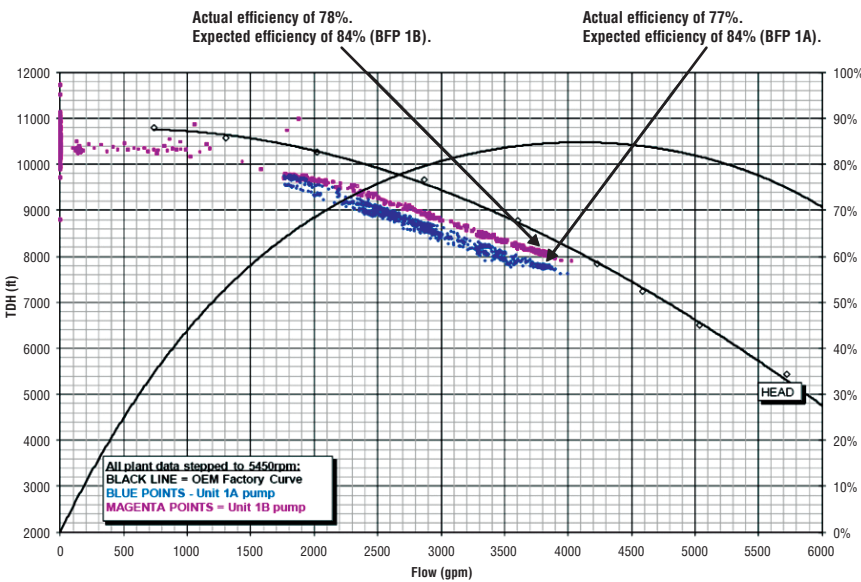
Actual Performance Curves for BFP 1A and BFP 1B

With the assistance of plant personnel, Flowserve engineers performed extensive onsite testing and analysis in 2010. Ultrasonic flow instrumentation and IPS Wireless™ sensors were installed at several key monitoring points to capture flow and pressure data respectively, and the data was transmitted to a central receiver. Plant DCS system provided temperatures and turbine speed data. Redundant pressure and flow data from the plant's DCS was compared to test data for validation purposes. Testing showed the pumps were operating approximately 8% below BEP.
