# High-efficiency Impeller Reduces Energy Usage and Shaft Wear

ISO 13709/API 610 (BB2) Process Pump Upgrade

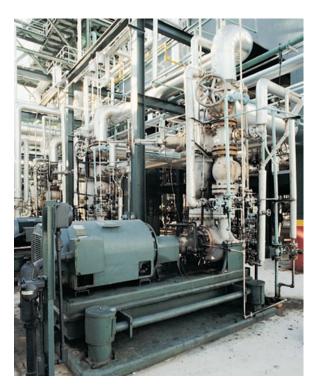
The pre-upgrade assessment clearly indicated significant energy consumption savings would be achieved from the recommended upgrades. This financial analysis did not include operational savings that would also be realized from extended plant uptime as a result of the improved rotor-dynamics. When implemented, the upgrade delivered the results shown.

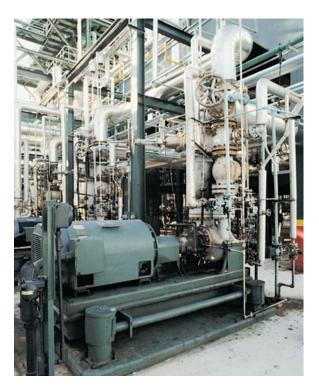
The pre-upgrade assessment clearly indicated significant energy consumption savings would be achieved from the recommended upgrades. This financial analysis did not include operational savings that would also be realized from extended plant uptime as a result of the improved rotor-dynamics. When implemented, the upgrade delivered the results shown.

Total Energy Cost (0.06/kW•h)	USD 115 632
Energy Consumed	1 927 200 kW∙h
Annual Running Hours	8760 hr
Power Consumption	220 kW
