Re-engineered Components Increase Slurry Pump Repair Interval

Rapid Prototyping and Materials Upgrades Save US\$240 000 Every Two Years

Bulletin FSG-SS-019 (E/A4) Printed in USA. March 2011. © Flowserve Corporation

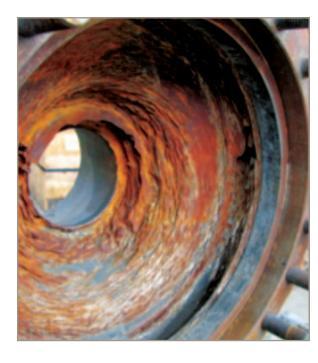
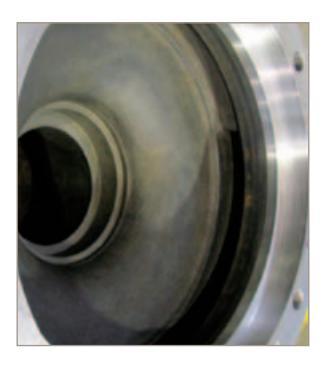
Casings Before and After

To start, Flowserve acquired and examined one of the chemical plant's severely eroded pumps. Using three-dimensional mapping technology, Flowserve engineers created highly accurate models of the casing, cover and impeller. These models were used to produce 12% chrome castings with hydraulics comparable, if not superior, to the competitor's original product.

With the new castings in hand, Flowserve technicians applied a boron diffusion treatment to all wetted surfaces. Not a coating but a through hardening technique wherein the microstructure of the base metal is metallurgically altered, the boron diffusion process significantly increases the surface hardness, and, therefore, the erosion resistance of treated components.

To prevent internal eddy currents from creating erosion points between mating pieces, a phenomenon identified during examination of pump remains, Flowserve engineers added integral wear rings on the pump casing, cover and impeller. All wear rings were hardened via direct laser deposition (DLP) to help maintain the proper running clearances for optimum hydraulic performance.
