Circulating Pump Re-rate Increases Efficiency 23% and Extends MTBPM 50%

57APH Mixed Flow Circulating Water Pump

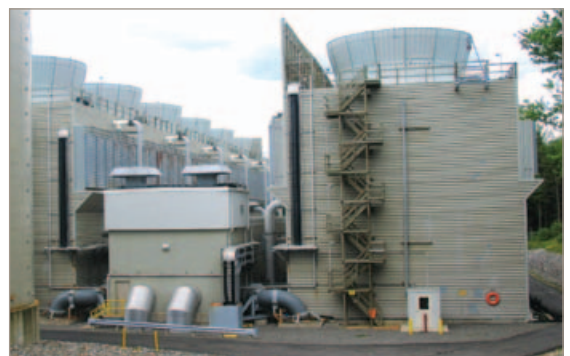
Inspection of two CWPs during a planned outage at a two unit, combined cycle power station revealed cracking at the interface of the suction heads and guide vanes. Further examination revealed the guide vanes were oscillating during operation, causing the pumps to vibrate significantly. It was clear the suction heads would need to be replaced. Because the pumps were operating well below BEP, however, the station operators hoped to incorporate the pump repair into a larger project of maximizing the efficiency of the entire circulating water system. And, if possible, the station operators would like to have the flexibility to operate both units at full power on one CWP.

To address the long-term goals, Flowserve engineers proposed a comprehensive assessment of the entire circulating water system. The results of this assessment would provide the New England power station with the best operating conditions for the circulating water pumps, enabling them to operate at BEP. To stabilize the guide vanes while the assessment was being performed, Flowserve engineers recommended the guide vanes be cut back to approximately 1/3 of their original length and ground smooth. In addition to buying time, this action reduced CWP vibration levels as the vanes were no longer oscillating during operation.

After performing a life cycle cost analysis, Flowserve engineers recommended re-rating the CWPs to an operating design point and corresponding BEP that more accurately reflect service conditions when both generating units are operating at 100% power. As a result, pump efficiency increased approximately 23%. The approximately US\$800 000 upgrade also included new suction heads for each pump.
